# RECENT FINDINGS IN JSW, ANJAR

**Asset Name:** Screw Down Blower 1

**Fault Diagnosed:** Unbalance, Minor misalignment

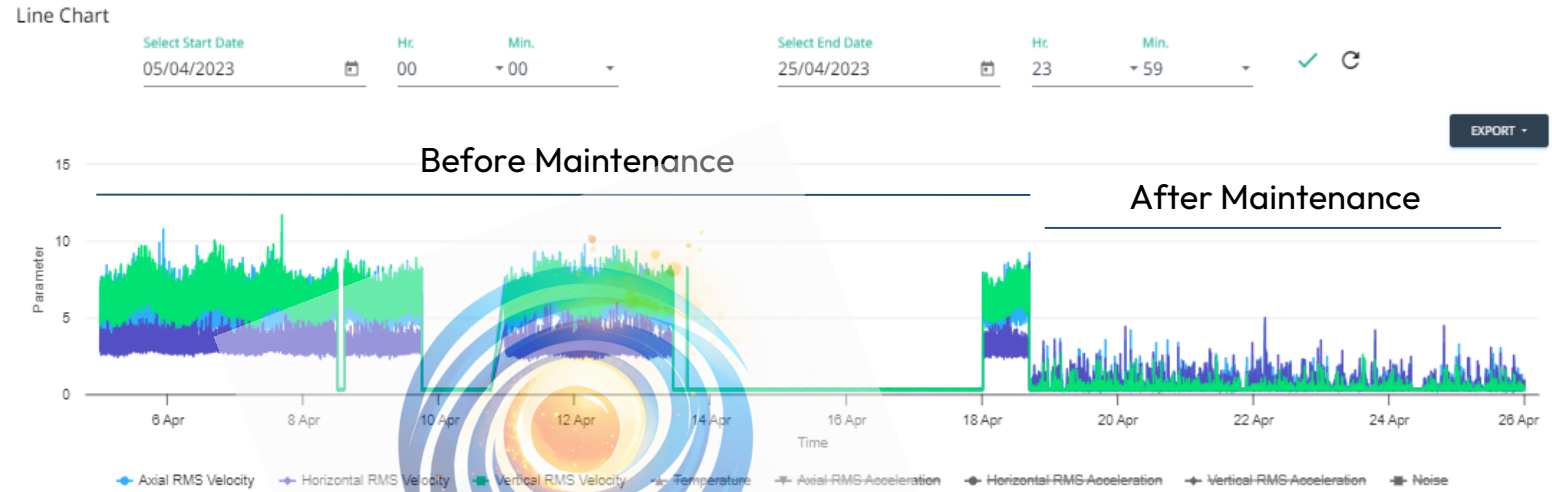
Motor DE Trend

DIRECTION	BEFORE	AFTER
HORIZONTAL	4.1	1.5
VERTICAL	6.7	0.8
AXIAL	6.0	1.9

DIRECTION	BEFORE	AFTER
HORIZONTAL	3.4	0.8
VERTICAL	5.1	0.9
AXIAL	5.8	1.2

- As per ISO-10816 standard Vibration level are in the **MARGINAL** condition.
- As per Analysis we have found that there is an Imbalance and alignment issue on the machine
