CASE STUDY OF SRF LTD, INDORE

Asset Name: 4 Stage Gearbox

Asset Name: MDO Roller 8

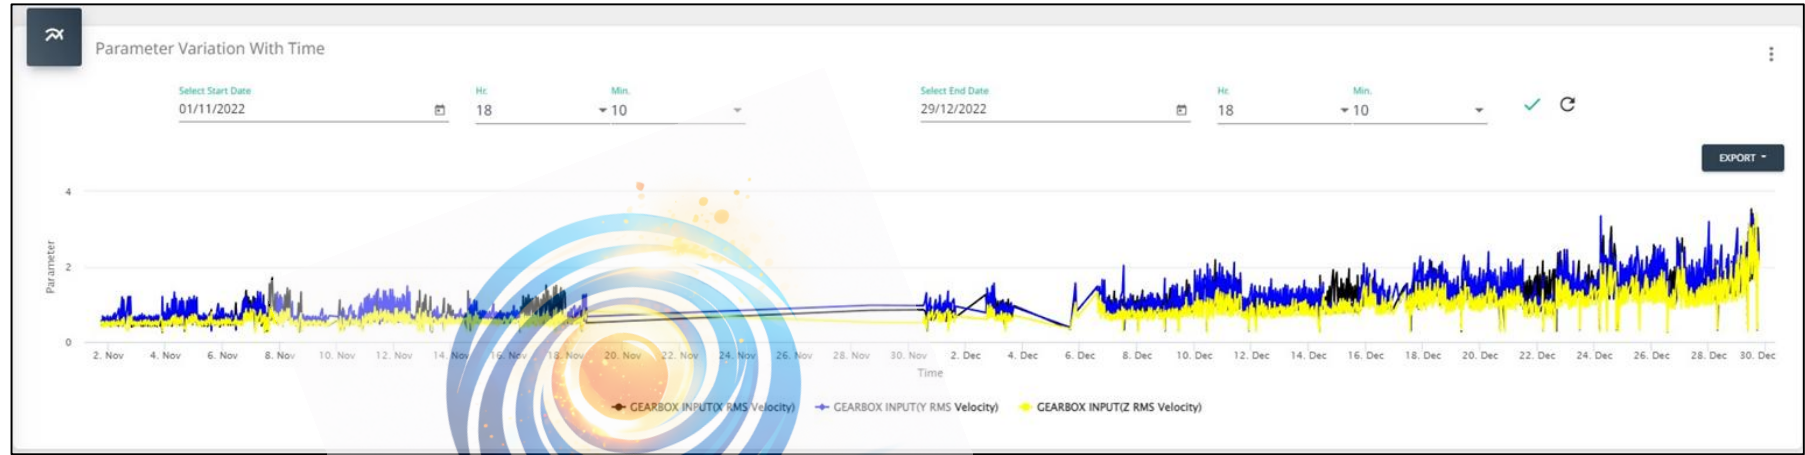
Gearbox Input Velocity Before Trend

DIRECTION	BEFORE	AFTER
HORIZONTAL	2.8	2.1
VERTICAL	3.7	2.2
AXIAL	2.2	1.4

Before - Error Reporting - 2nd Nov- 30th Dec.
 After - After Correction - 1st Jan- 1st Feb.

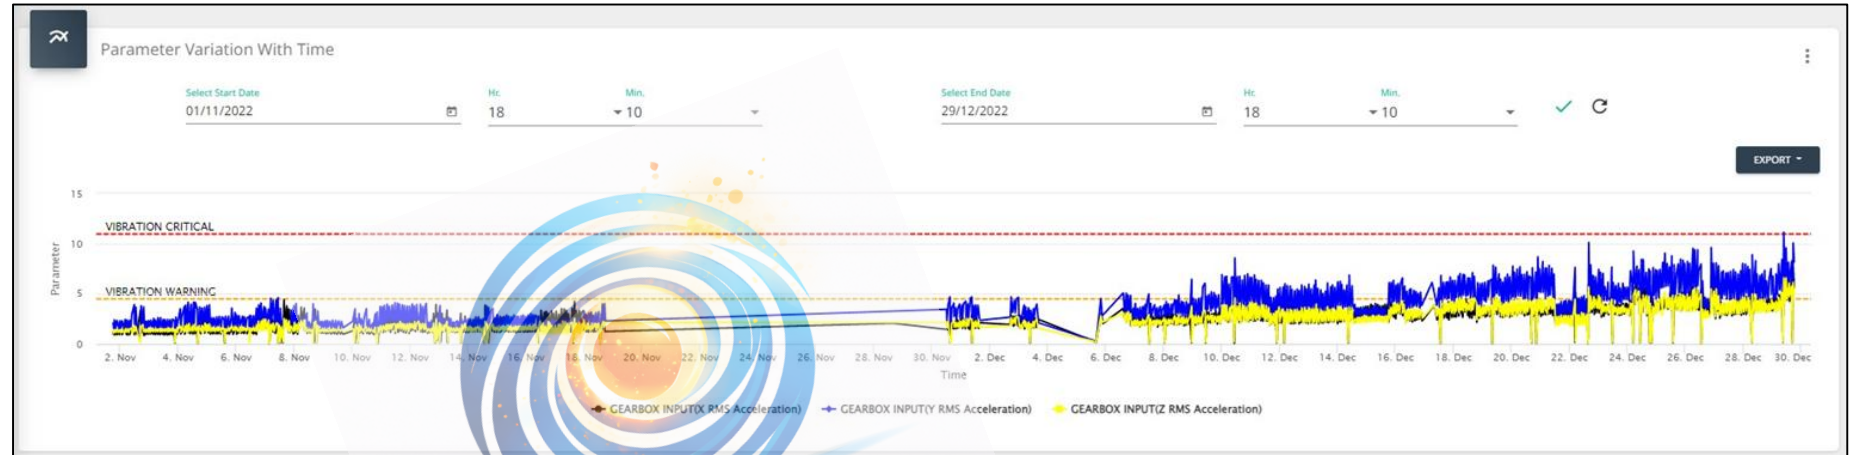
Gearbox Input Acceleration Before Trend

DIRECTION	BEFORE	AFTER
HORIZONTAL	9.6	4.1
VERTICAL	9.7	4.9
AXIAL	7.9	2.7

Before - Error Reporting - 2nd Nov- 30th Dec.
 After - After Correction - 1st Jan- 1st Feb.

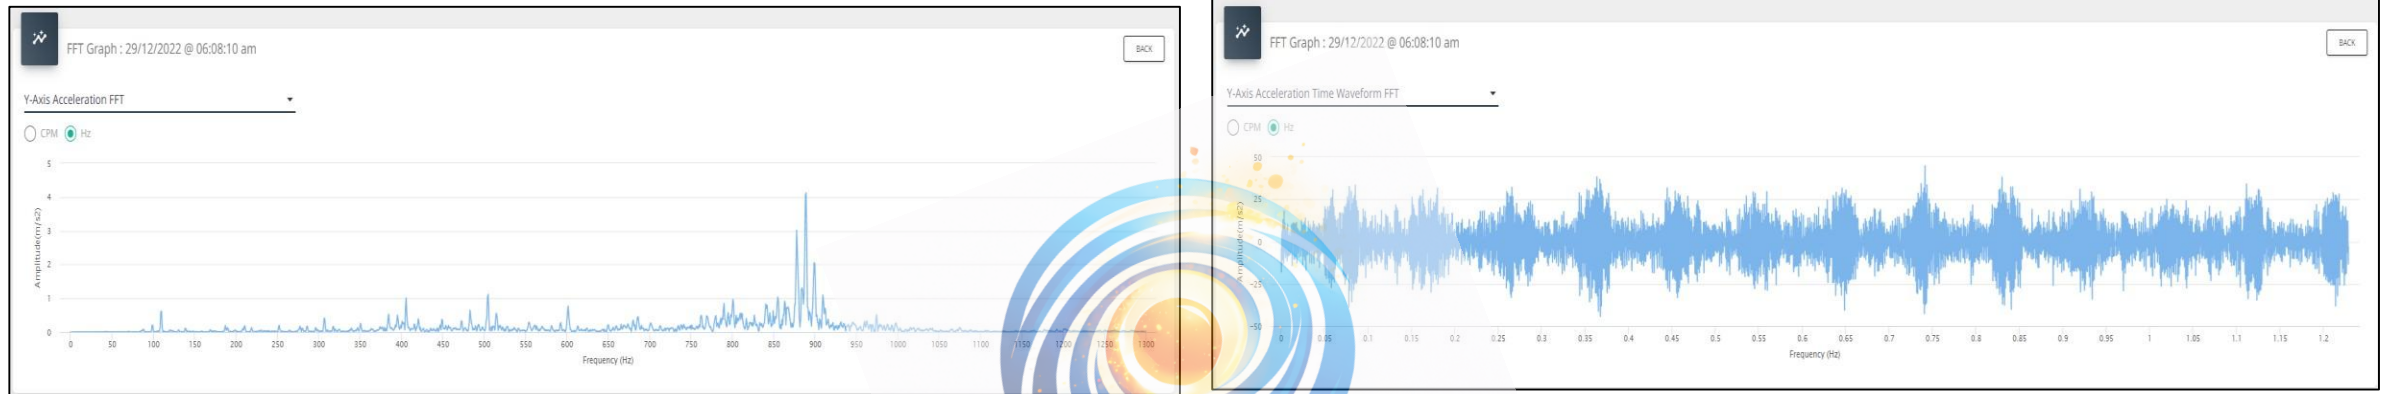
Gearbox Input

❑ Observation for GEARBOX INPUT:

- As per ISO-10816 standard Vibration level are in the **Warning** condition.
- High Frequencies has been observed which might be the gear mesh frequency for detailed analysis no. of gear teeth required.
- High Impacting has been observed in time waveform which indicates some kind of wear and tear has been started in the Gearbox.

❑ Recommendation for GEARBOX INPUT:

- Vibration is Increasing Gradually in the Historical trend (last slide) for Velocity as well as Acceleration.
- Kindly Replace the Gear Oil & Inspect the Gearbox for wear & tear of the Gear teeth and Bearings .

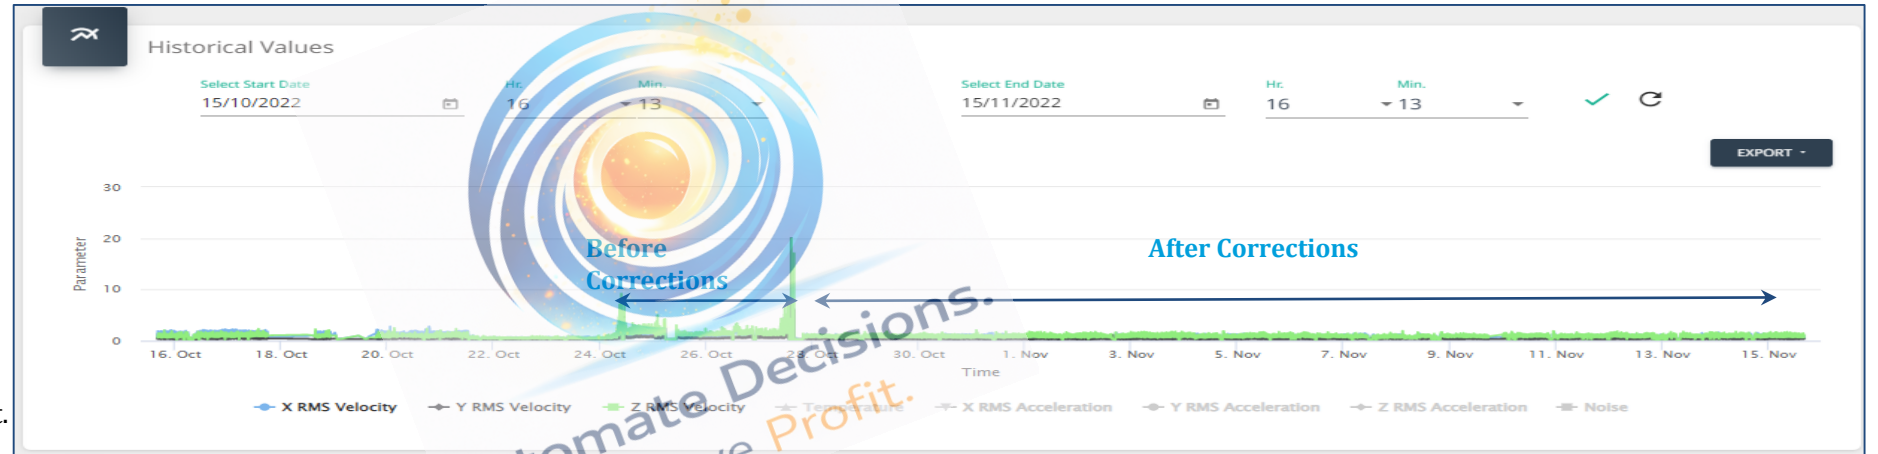
Automate Decisions.
 Improve Profit.
Roller Non-Drive END - Velocity

DIRECTION	BEFORE	AFTER
HORIZONTAL	3.6	1.4
VERTICAL	3.7	1.2
AXIAL	2.5	1.1

Before - Error Reporting - 24th Oct- 28th Oct.
 After - After Correction -28th Oct- 15th Nov.

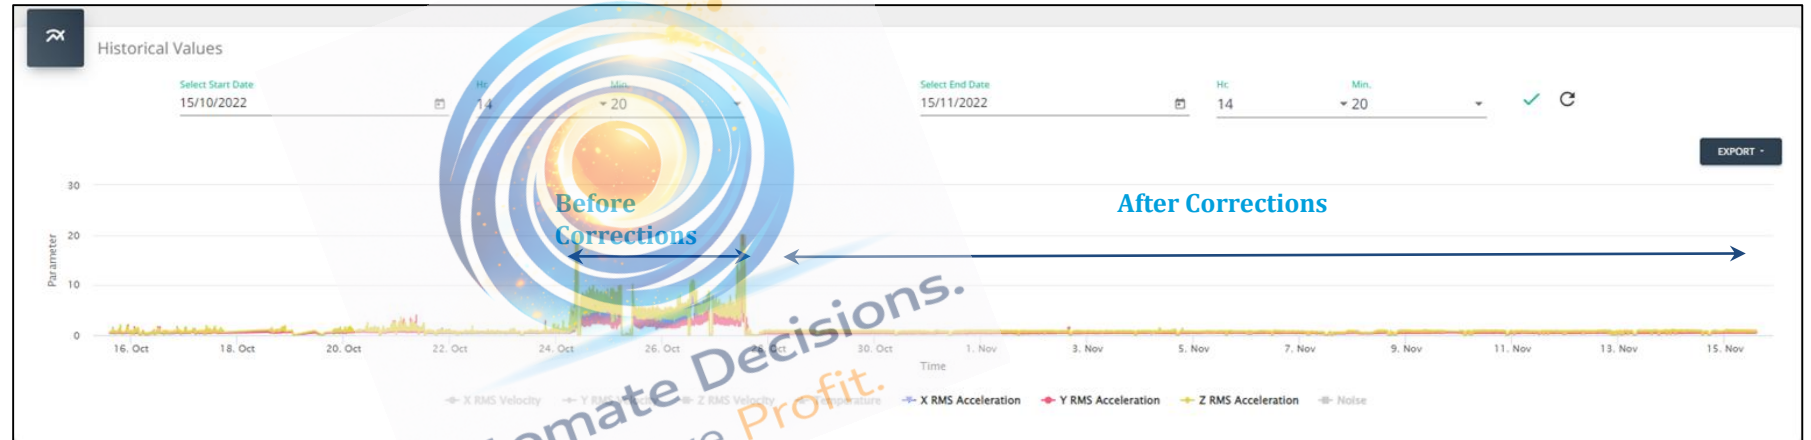
Roller Non-Drive END - Acceleration

DIRECTION	BEFORE	AFTER
HORIZONTAL	19.6	2.5
VERTICAL	10.7	2.1
AXIAL	10.1	1.7

Before - Error Reporting - 24th Oct- 28th Oct.
After - After Correction -28th Oct- 15th Nov.

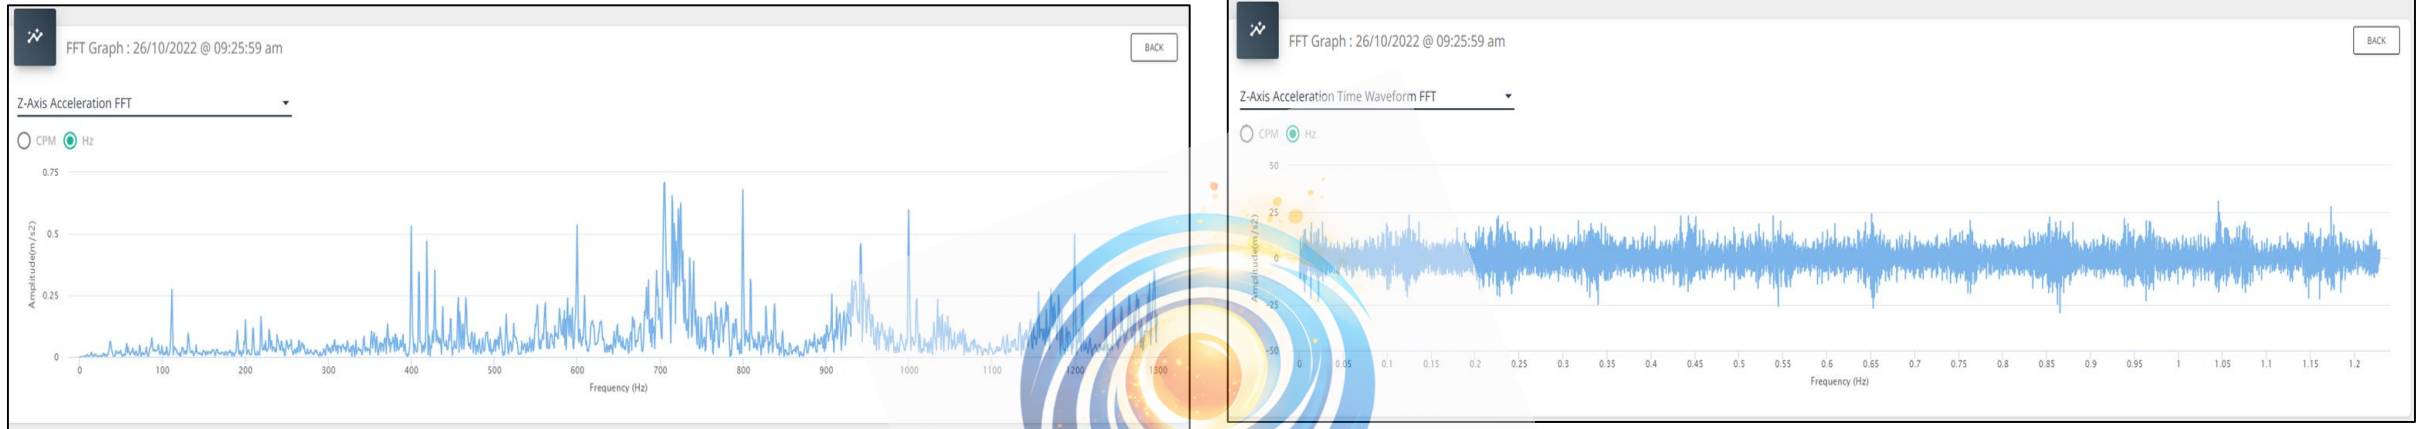
MDO Roller NDE

❑ Observation for MDO ROLLER NDE:

- As per ISO-10816 standard Vibration level are in the **Warning** condition.
- High Frequency peaks has been Observed (Left Image) this indicates Bearing issues in the Machine.
- Observed Impacting (Right Image) in Time waveform that means there is a Deterioration in the Bearing.

❑ Recommendations for MDO ROLLER NDE :

- Lubrication of the Bearings has been done on 26-10-2022.
- Kindly check the Bearing condition/ Clearances in the Next Opportunity.
- As per Discussion we will monitor the Machine again for further improvements. Keep machine under Observation.
