CASE STUDY OF SRF LTD, INDORE

Asset Name: 4 Stage Gearbox

Asset Name: MDO Roller 8

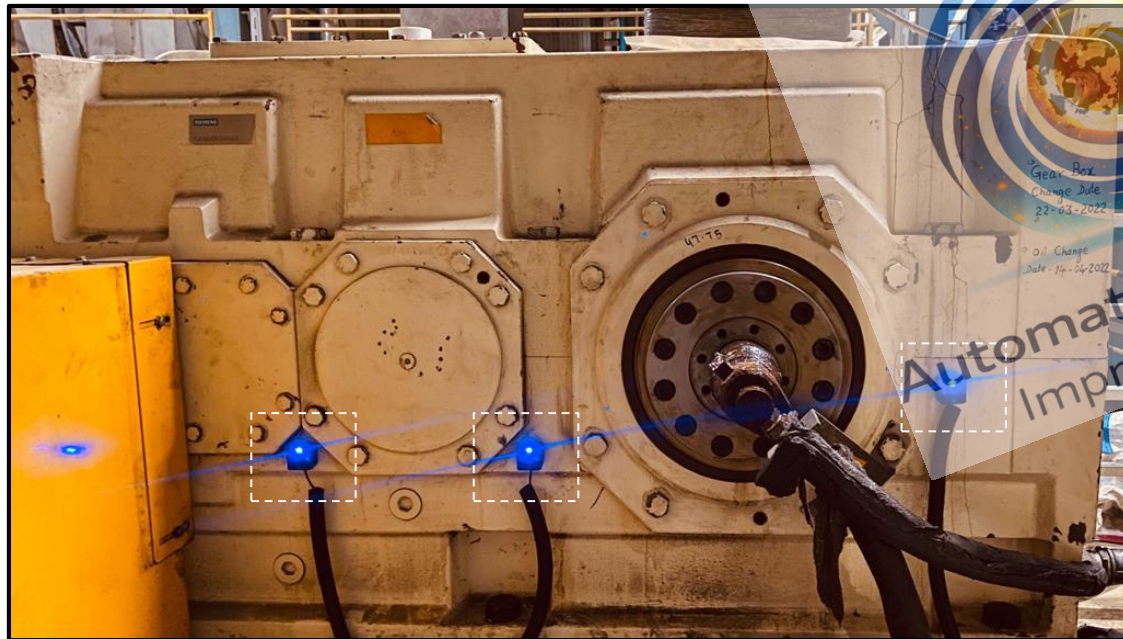
Fault Diagnosed: Bearing Impacting Found via Sensor - Gear Input Drive End.

Final Action - Bearing replaced by the Client

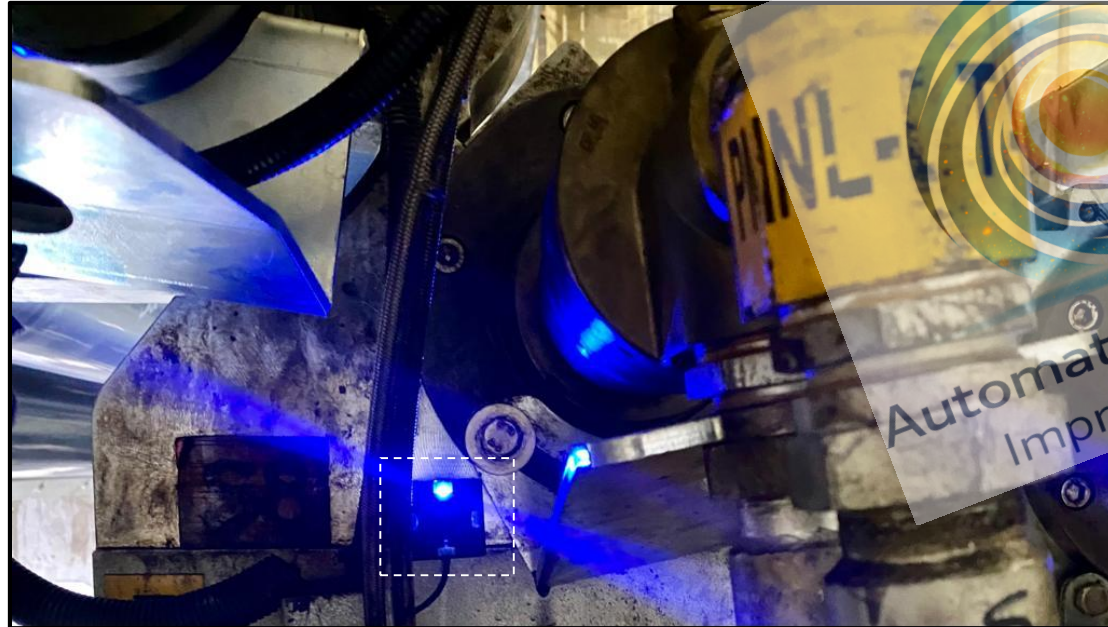
Fault Diagnosed: Bearing Impacting has been Observed via
Sensor - Roller Non-Drive End.

- Lubrication of the Bearings has been done on 26-10-2022.
- Kindly check the Bearing condition/ Clearances in the Next Opportunity.
- As per Discussion we will monitor the Machine again for further improvements. Keep machine under Observation.
